# NASA/TM-2009-215316 NESC-RP-05-113/05-034-E

# NESC Review of the 8-Foot High Temperature Tunnel (HTT) Oxygen Storage Pressure Vessel Inspection Requirements

NESC Review of the 8-Foot High Temperature Tunnel (HTT) Oxygen Storage Pressure Vessel Inspection Requirements

March 16, 2006

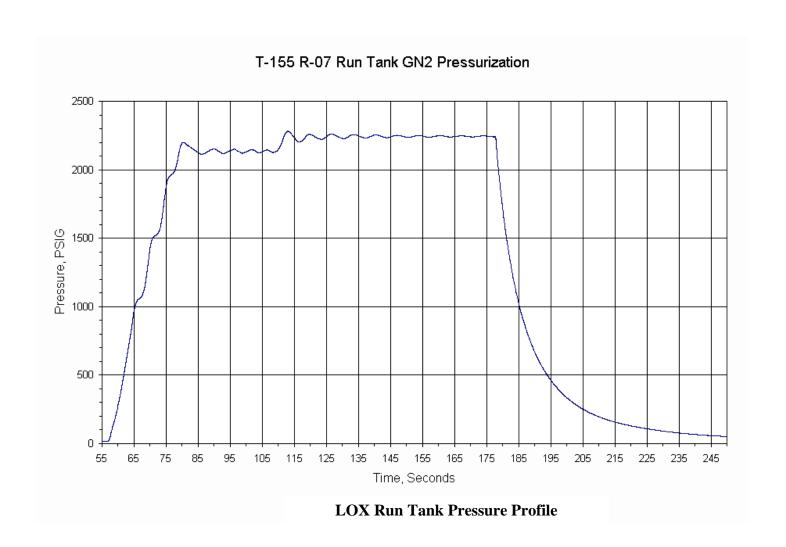
Appendix B. LOX Run Tank Sketch

- The tank was determined to be LBB by analysis.
- Monitoring of the vacuum level between the inner pressure shell and the external shell would identify the presence of through-cracks in the pressure shell and allow the facility to stop operations before catastrophic failure would occur.
